TORONTO HARBOUR STUDY 1976 to 1979 VOLUME 1 BACKGROUND INFORMATION

TORONTO HARBOUR STUDY

VOLUME I - BACKGROUND INFORMATION

W. S. Richardson
Great Lakes Surveys Unit
Planning and Co-ordination Section
Water Resources Branch
February, 1980

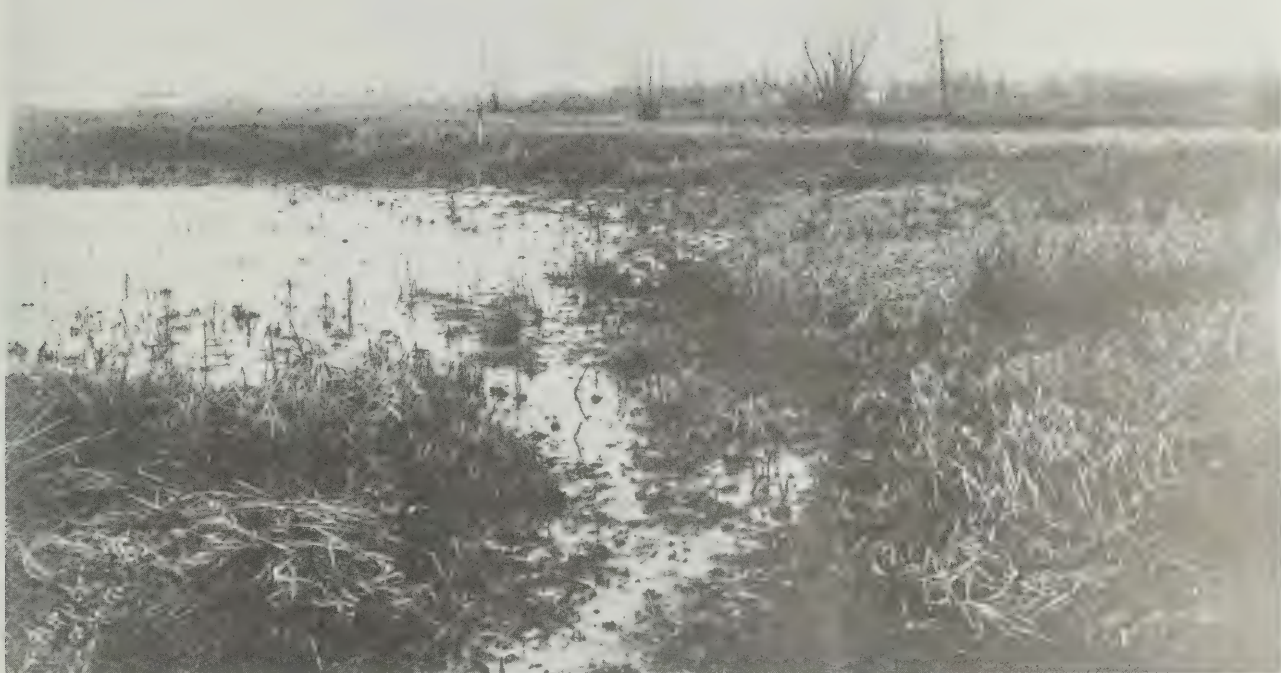
VIEW ①, Figure 5 — Looking west from the foot of Leslie Street, December 20, 1895.

Figure 6 — PHOTOGRAPHS OF VIEWS INDICATED IN FIGURE 5 .

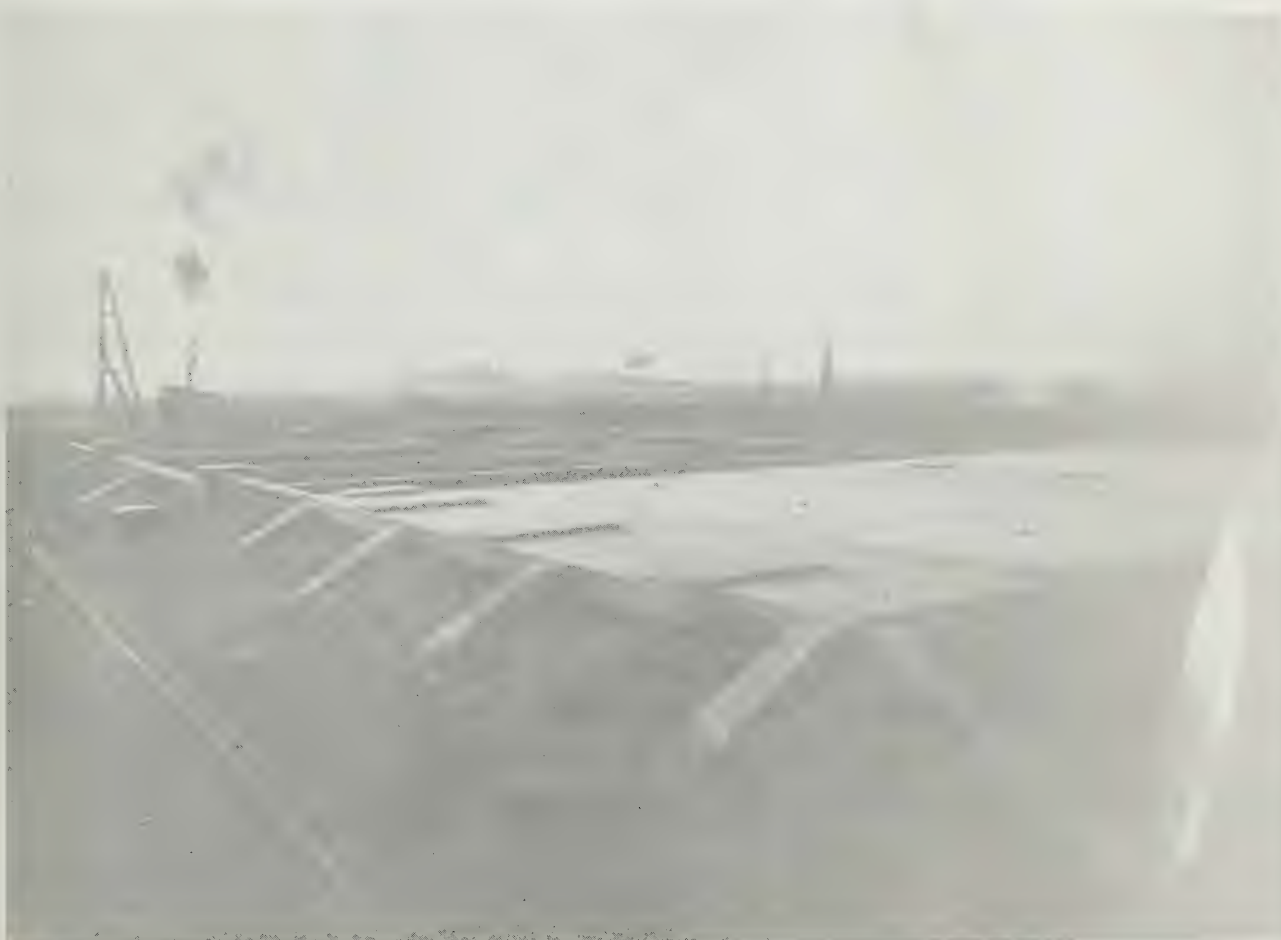
VIEW ②, Figure 5 — Imhoff Tanks (Primary Treatment Facility), Kew Beach, c. 1900.

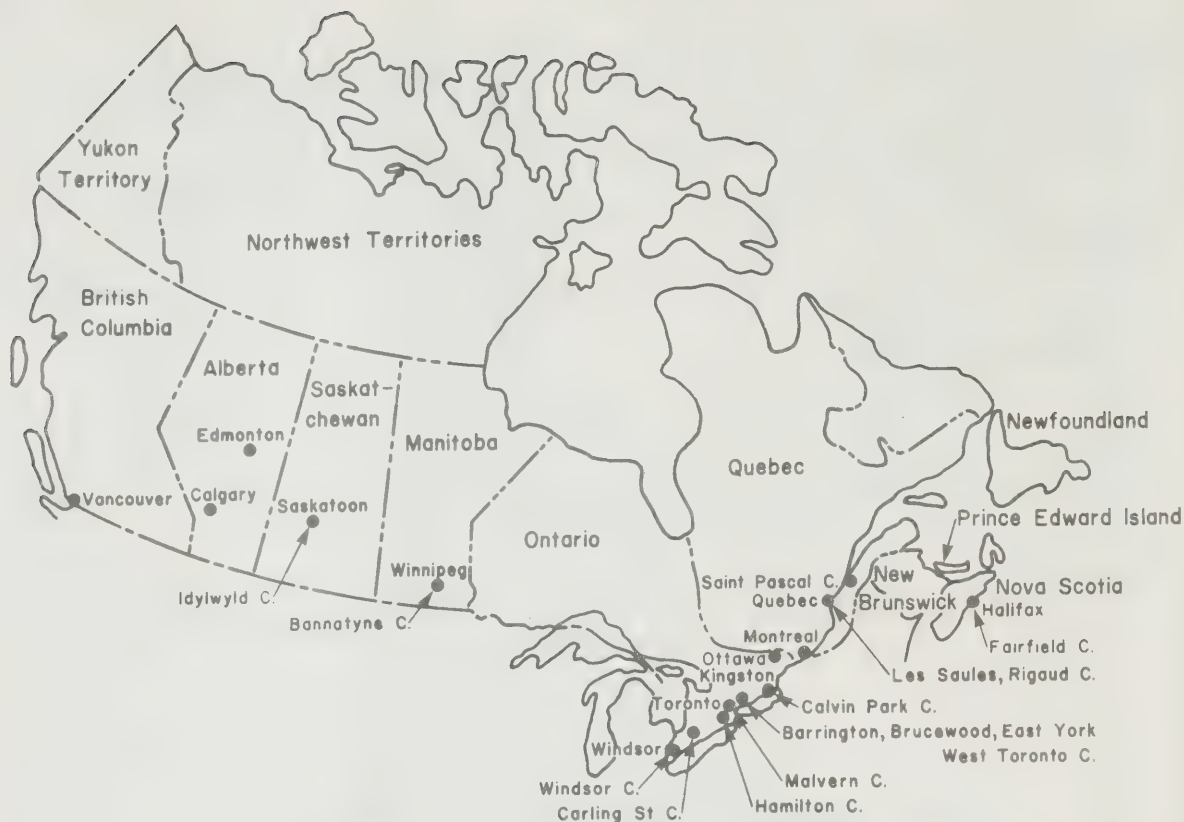
FIGURE 13 - SELECTED CANADIAN URBAN TEST CATCHMENTS

RANGE OF CONCENTRATIONS IN OBSERVED COMPOSITION OF COMBINED SEWAGE AND STORMWATER
